## A Survey of Thatched Buildings in Scotland

Thatch Survey of Scotland  
2014-15

A photographic survey of thatched buildings in Scotland, surveyed between May 2014 and August 2015 by Zoe Herbert (SPAB Scotland Officer), on behalf of the Society for the Protection of Ancient Buildings.

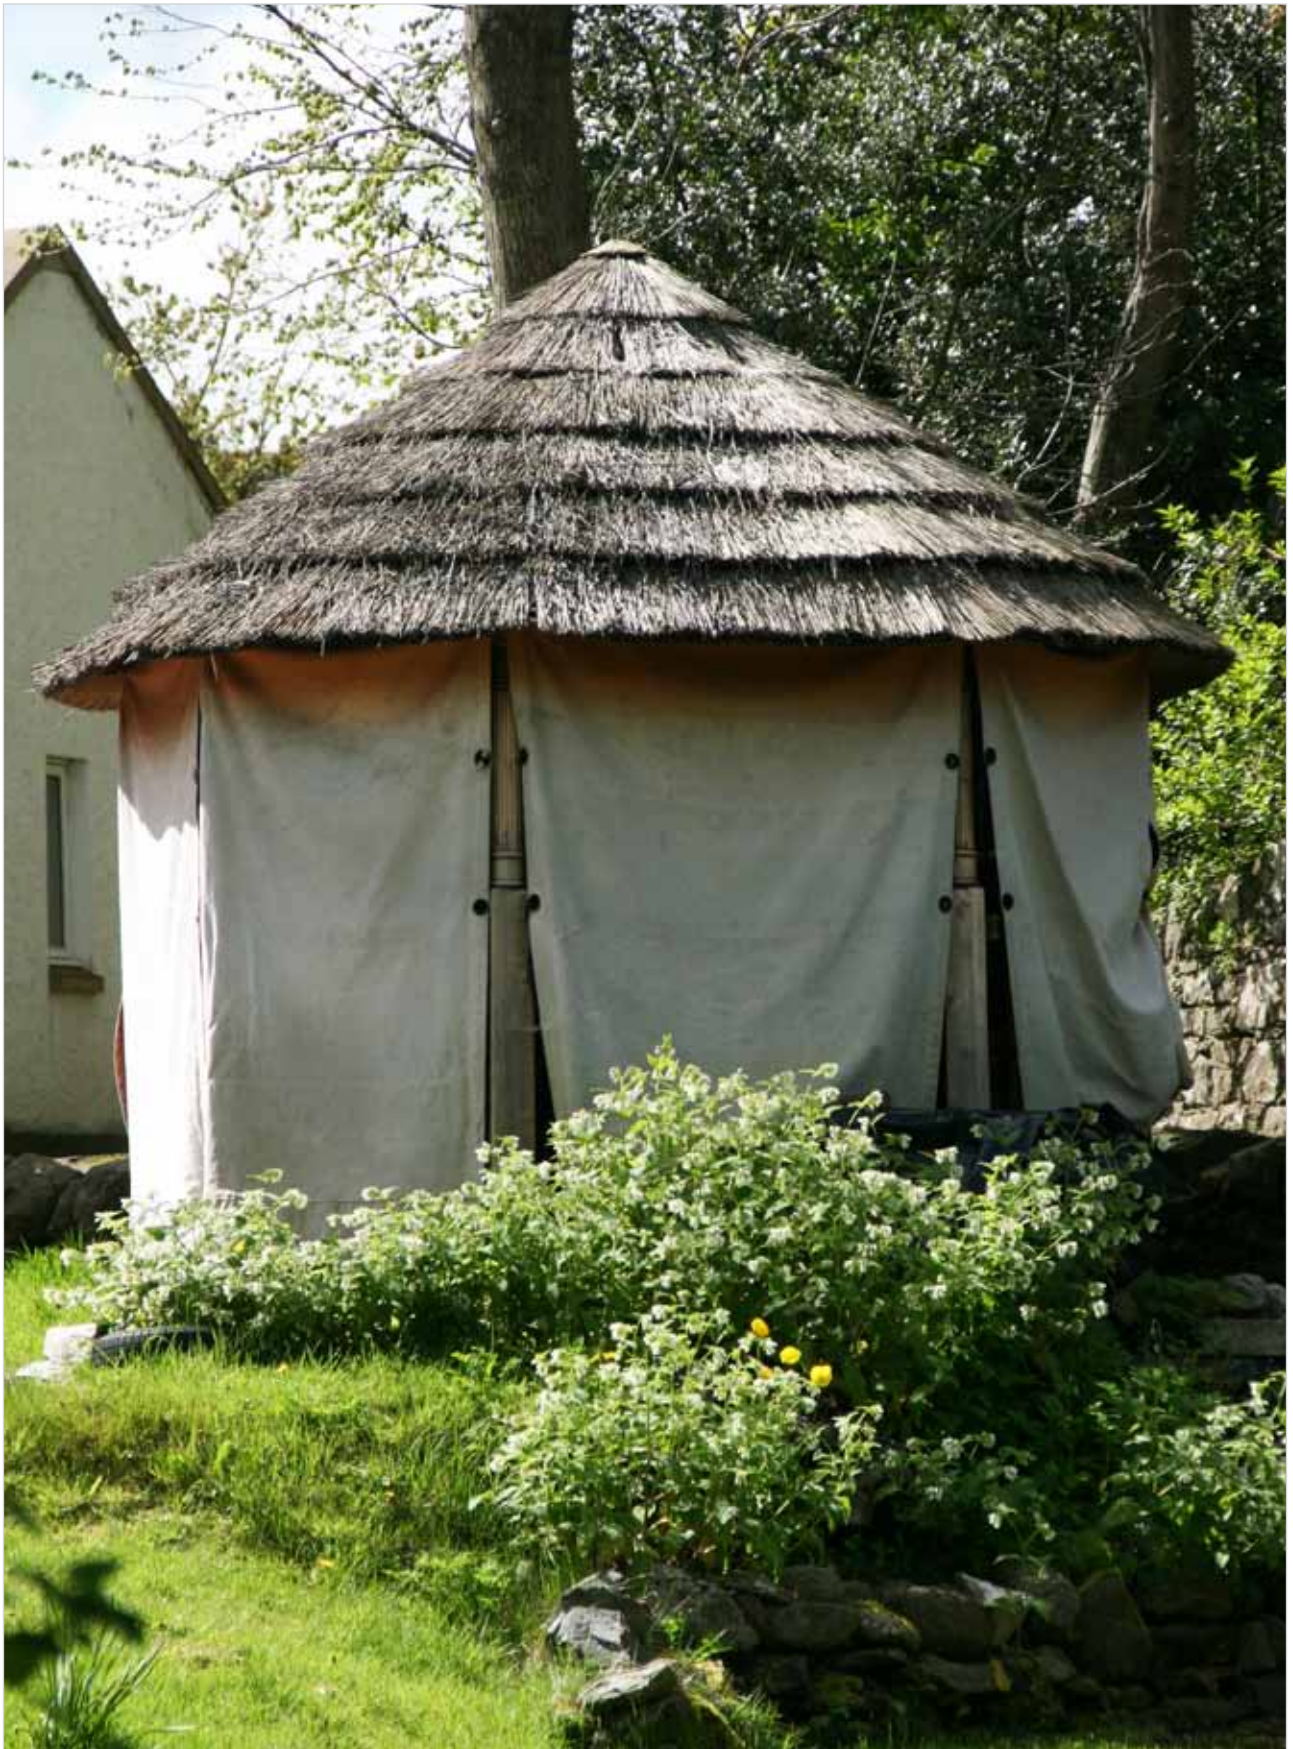
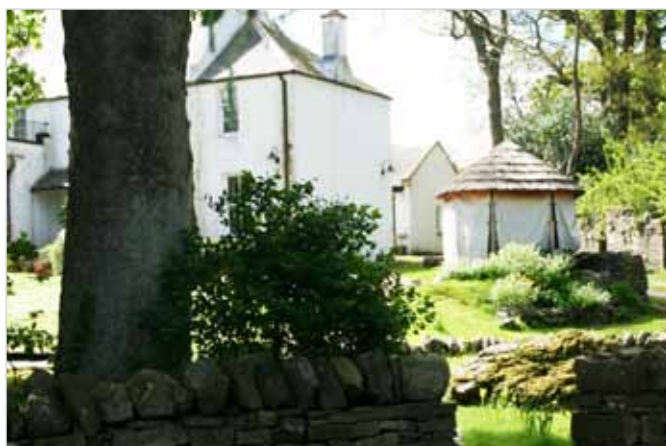
The Old Schoolhouse – Edinburgh

Condition of Thatch: ..... Good

Additional Notes: ..... In the front garden of 'The Old Schoolhouse', which is located next to a number of  
thatched cottages (see entries 059-063) in the village of Swanston, is a small thatched gazebo. It appears to  
be a modern structure, thatched in what looks to be reed. The conical thatched roof is stepped, with six layers  
overlapping one another, and has a small cap on the apex of unknown material.

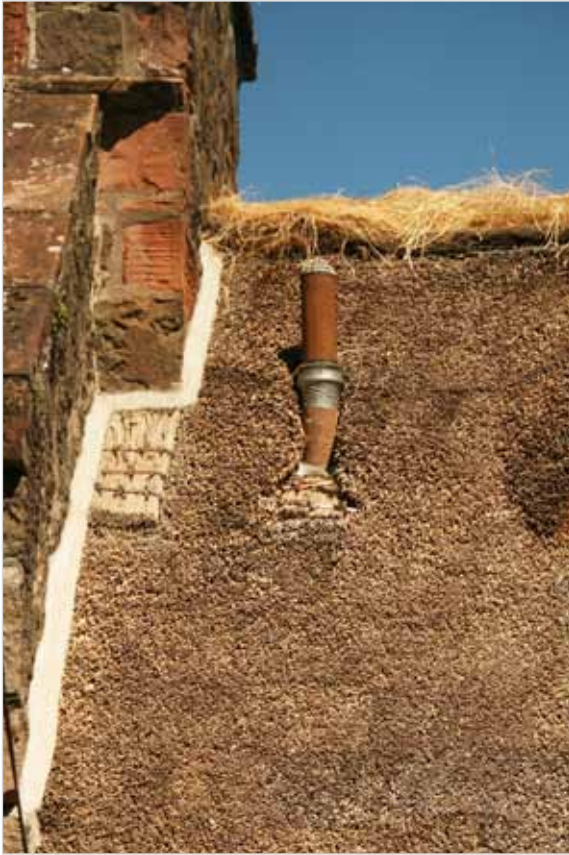
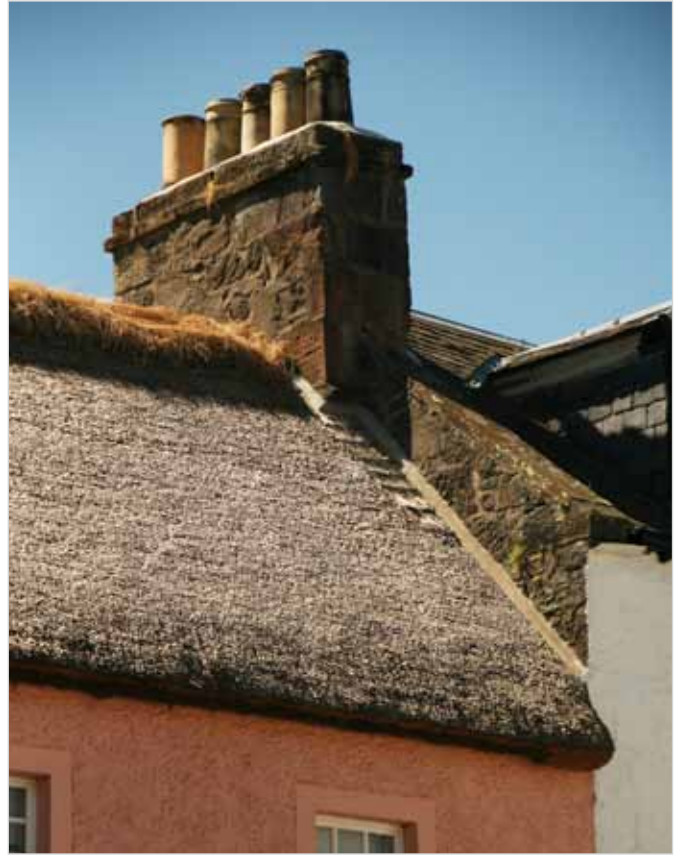
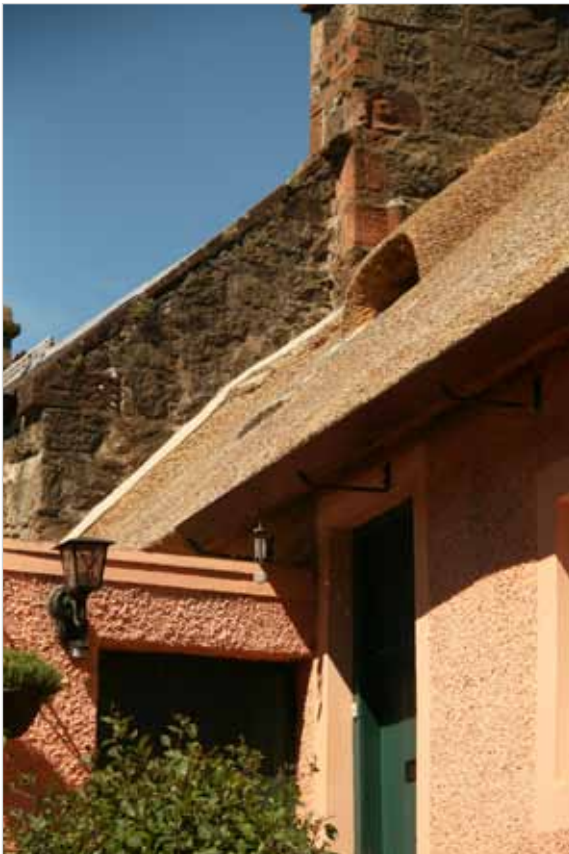
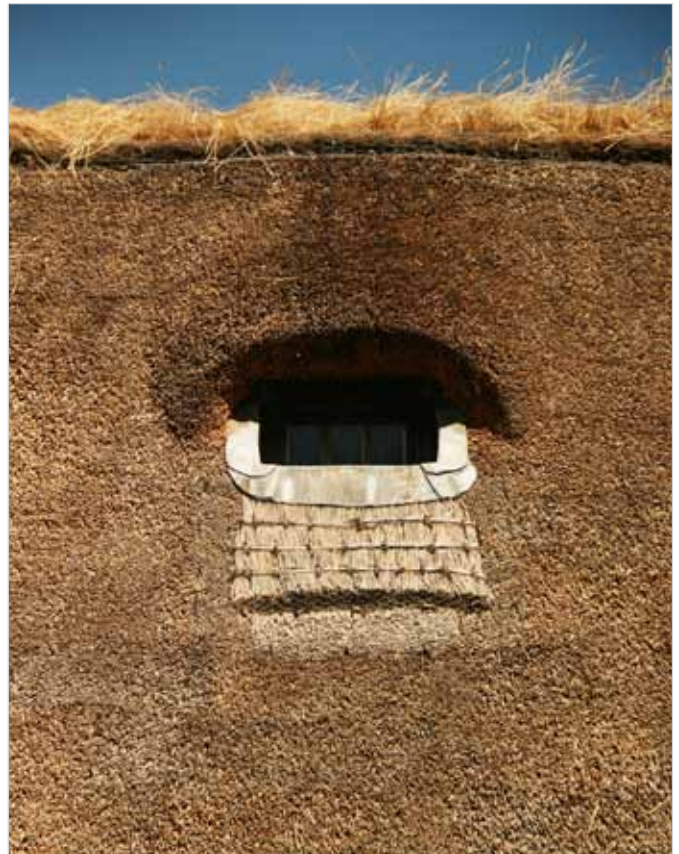
165-173 High Street – Fife

Condition of Thatch: ..... Good

**Additional Notes:** ..... 18th-century, two-storey block currently comprising two flats. On the front (south) elevation there are two visible repairs to the thatch directly below each chimney stack. On the back (north) elevation there are seven repair patches below each dormer window ventilation pipe and chimney stack. The repairs have been thatched in reed, like the rest of the roof, however, they have been secured to the roof using a different technique and have been scobed with what appear to be hazel spars. One of the current tenants stated that the repairs, which include a concrete barrier, were carried out in order to stop roots growing into the thatch.

..... The flourishing turf ridge has been netted, whilst the rest of the thatch is left uncovered other than where repairs have taken place (these have been covered in netting). The building was last thatched in 2013 and remains in a good, well-maintained condition. It has a snow board below the eaves on the rear elevation, above the entrance to the first-floor flat.

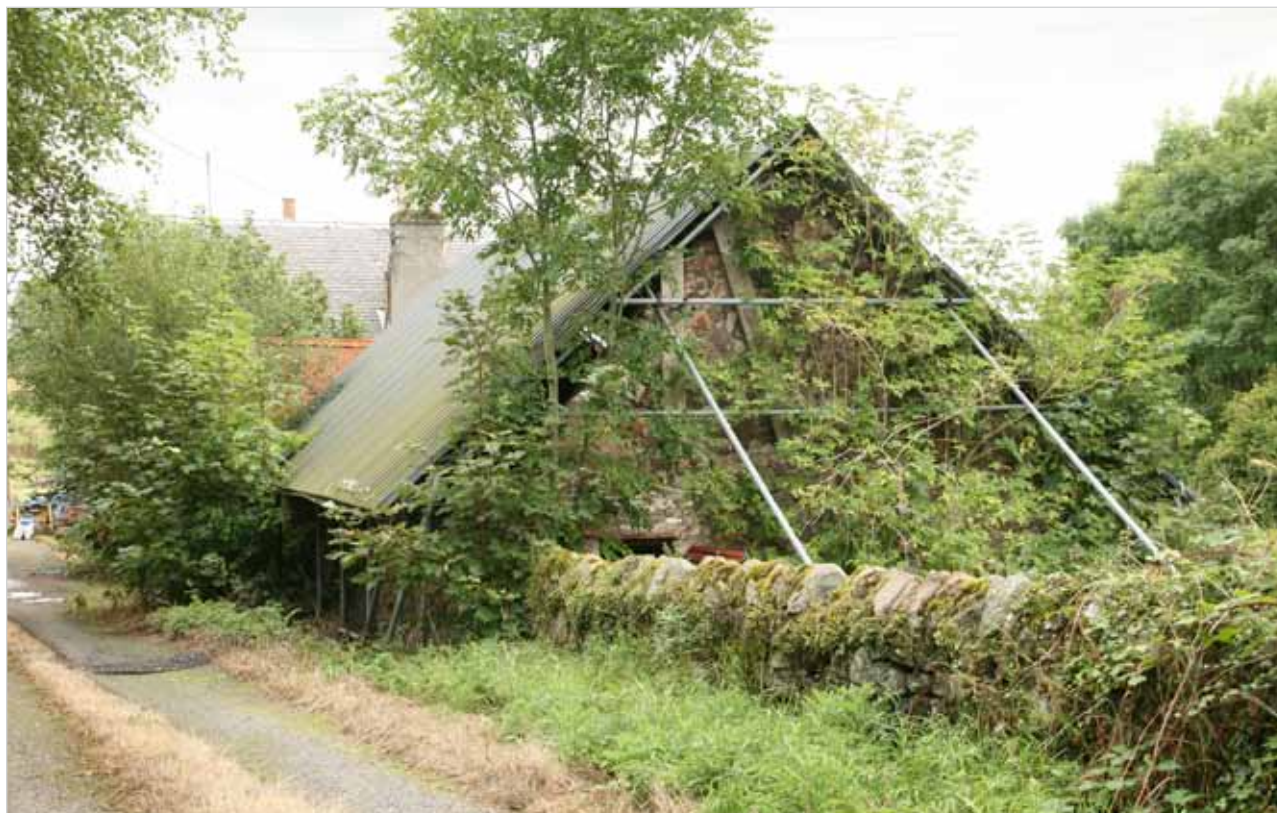
Address: ..... Macduff's Cottage

Buildings At Risk: ..... Yes

**Additional Notes:** ..... Former cottage, previously category B listed in 1984 but was delisted in 2014. The building, which was listed as being thatched, has been on the Buildings at Risk (BAR) Register since 1990 (BAR reference number 2009). The various BAR inspections since this time document the gradual deterioration of the thatched roof, and although a temporary roof has been in place for many years, no thatch remains.

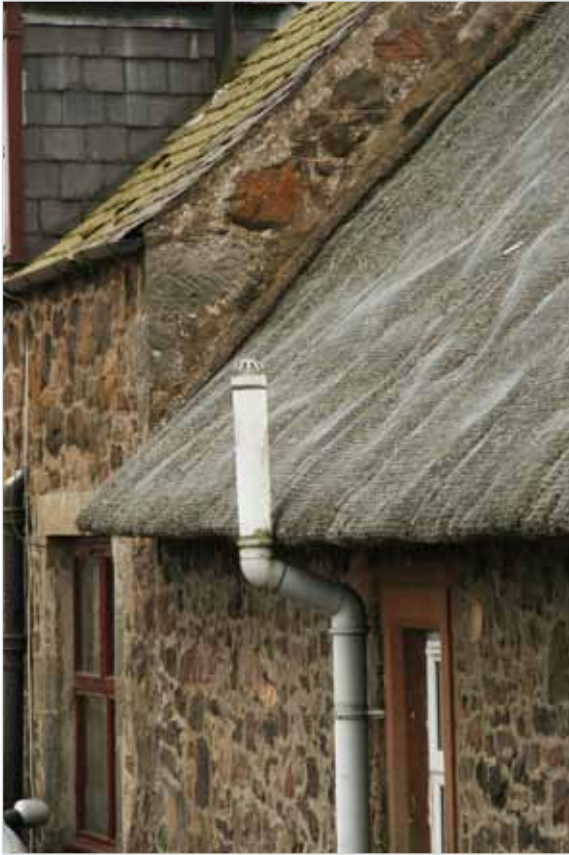
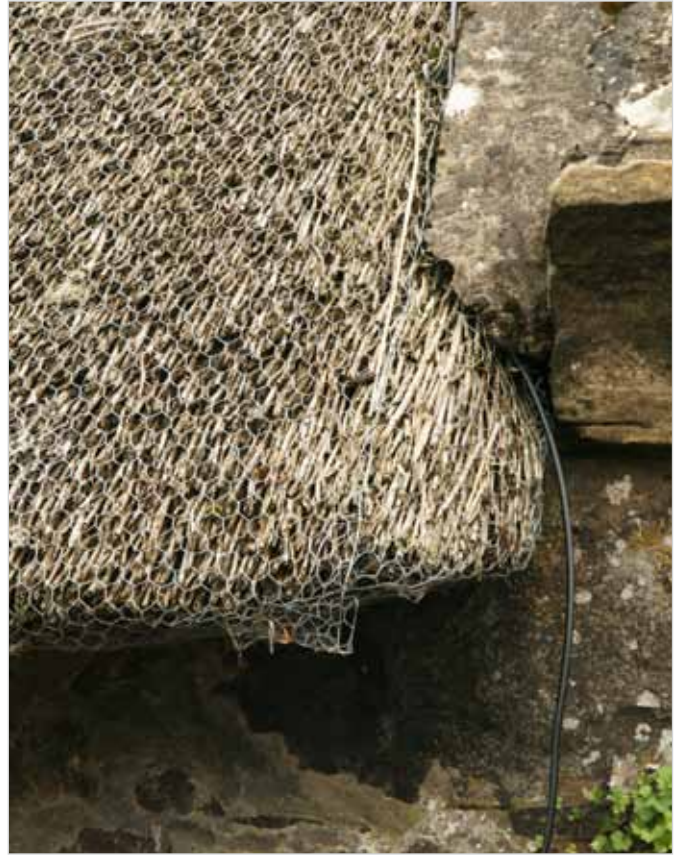
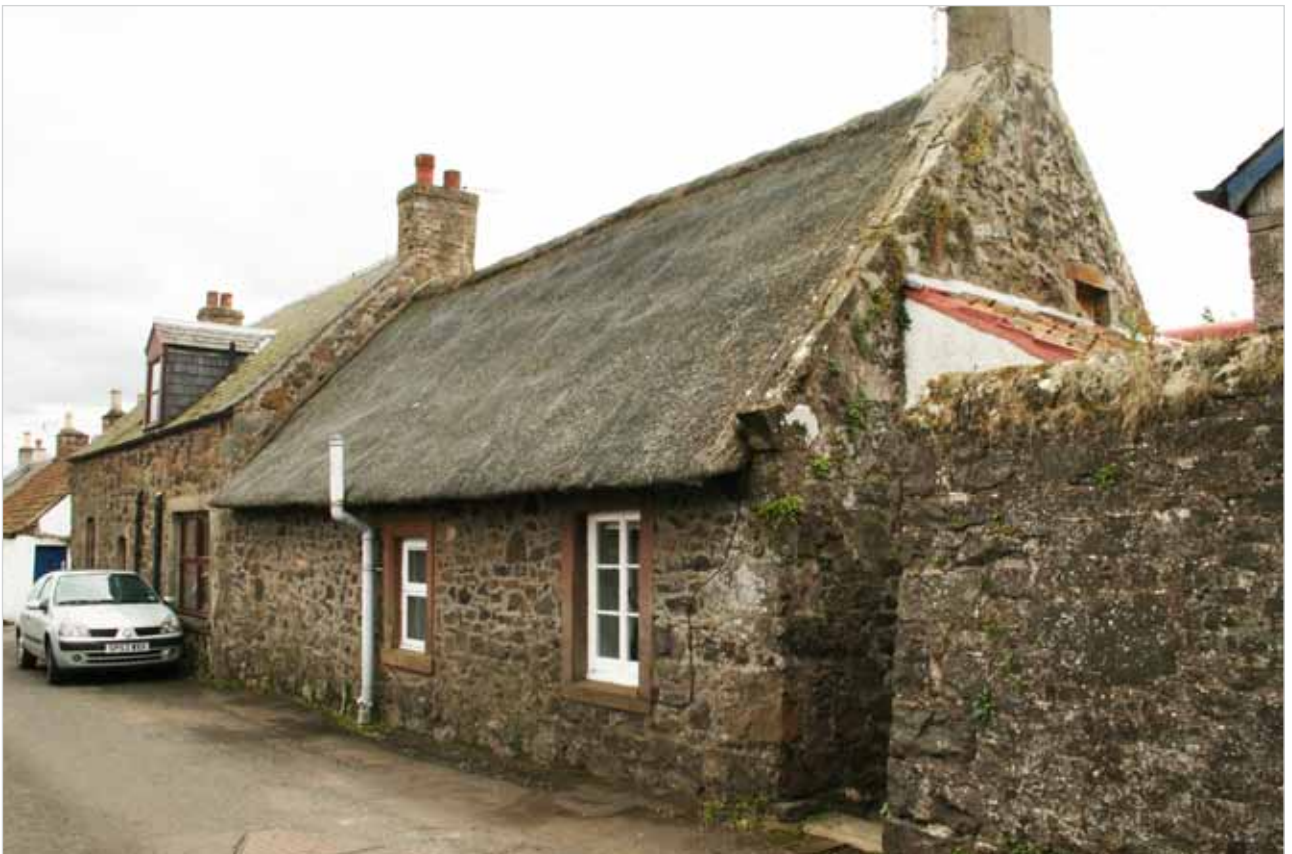
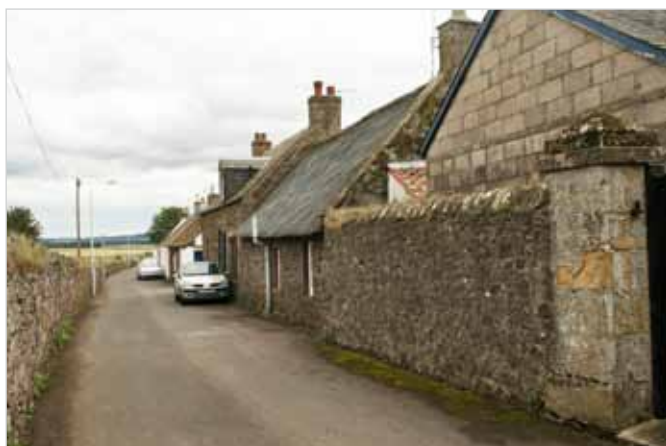
Address: ..... 11 Bow Road

Additional Notes: ..... 18th-century cottage, with 19th-century alterations. It was re-thatched in 1991 with the aid of a Historic Environment Scotland Thatched Buildings Maintenance Grant, and this would appear to be the last time the building was thatched. The entire thatch is netted, including over the ridge, which is held in place with metal pegs secured into the thatch. The thatch has deteriorated somewhat and the level of the thatch is uneven throughout; however, the netting is still intact and there are no signs of any major vegetation growth or significant damage other than a few loose reeds. The ridge appears to be thatched in heather; however, due to the ridge

..... Fair

being netted and its condition, this cannot be said for certain.

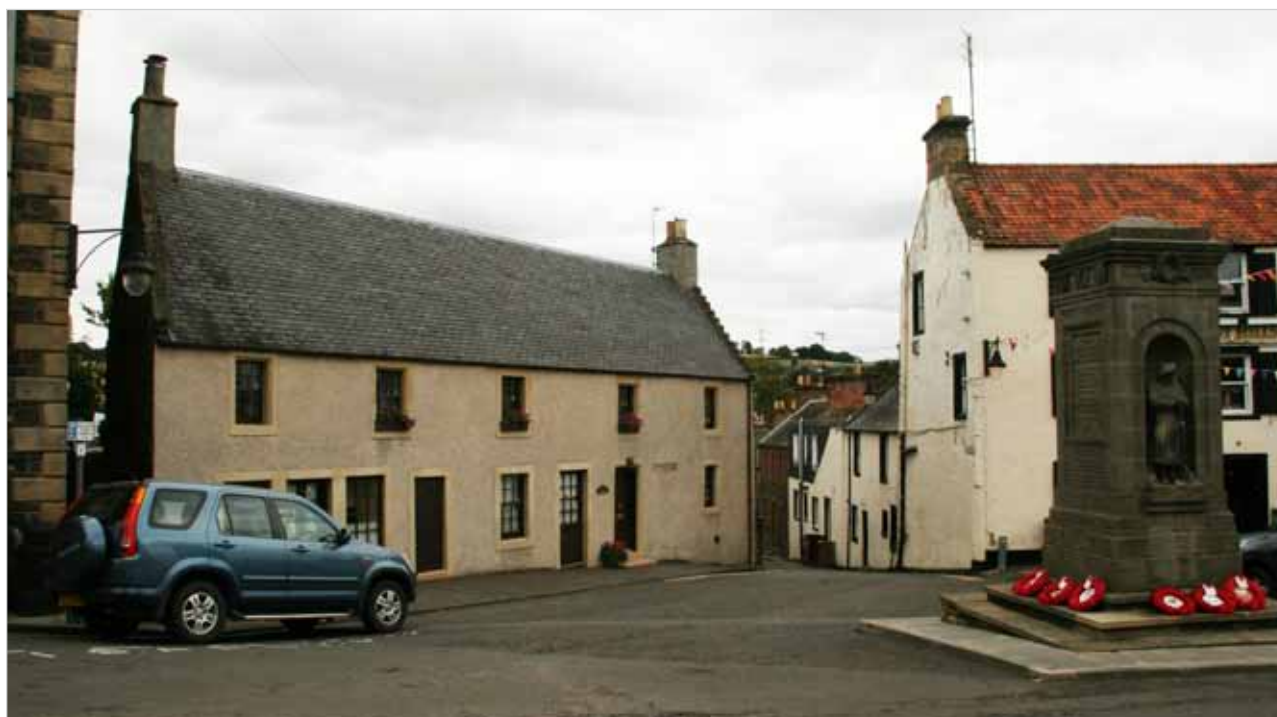
Address: ..... Brae House

**Additional Notes:** ..... 18th-century, two two-storey houses listed as being 'slated (thatch at back)'. The front pitch of the roof is slated. View to the back of the building could not be accessed on the day of visiting; however, web-based street view images appear to show that the back pitch of the roof is also slated. There appears to be no thatch left on this house; however further research into this building is required, and the listing description should be updated accordingly.

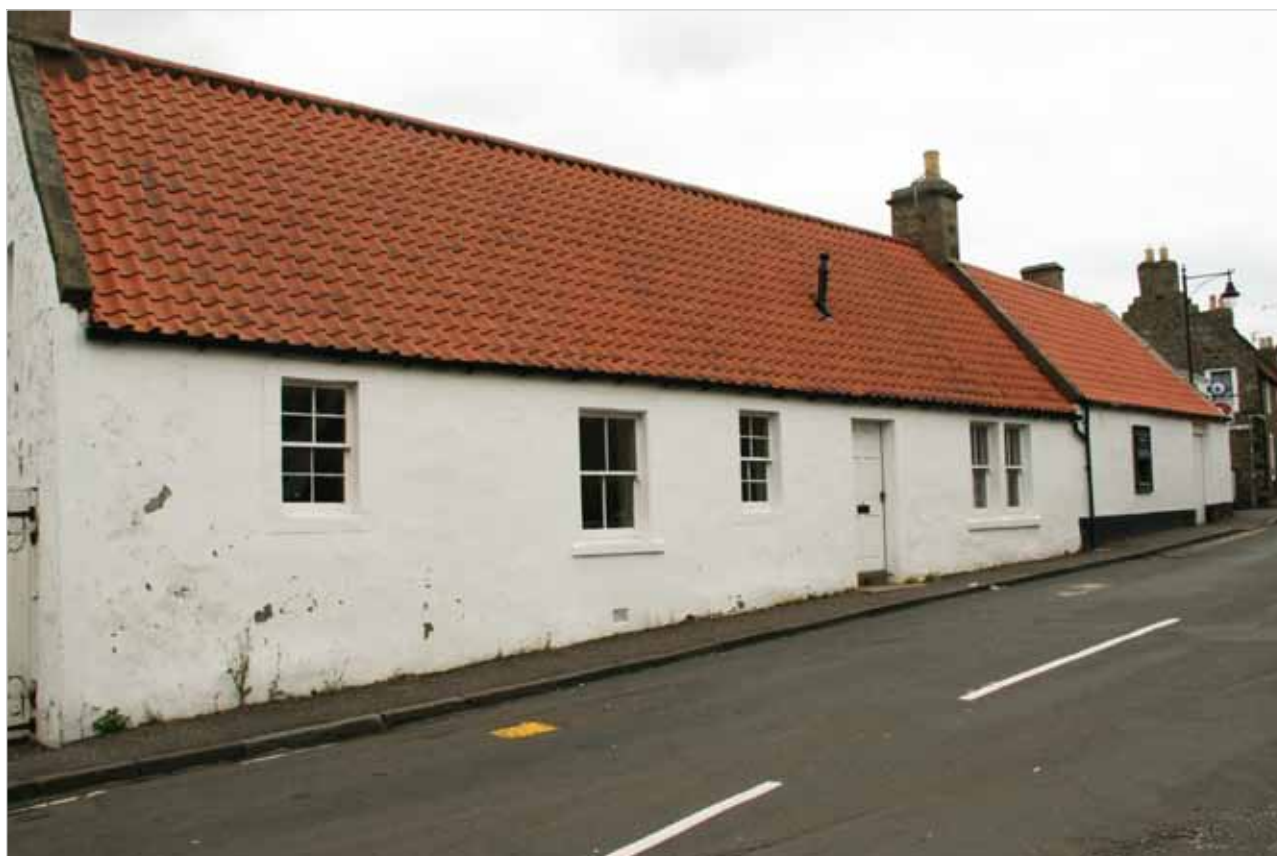
Address: ..... Ramleh

Additional Notes: ..... 18th-century cottage, listed as being thatched. The building at the location for this listing is not thatched and has a pantile roof. The height of the skewers would suggest it was possibly once thatched. The listing description for this building should be updated accordingly.

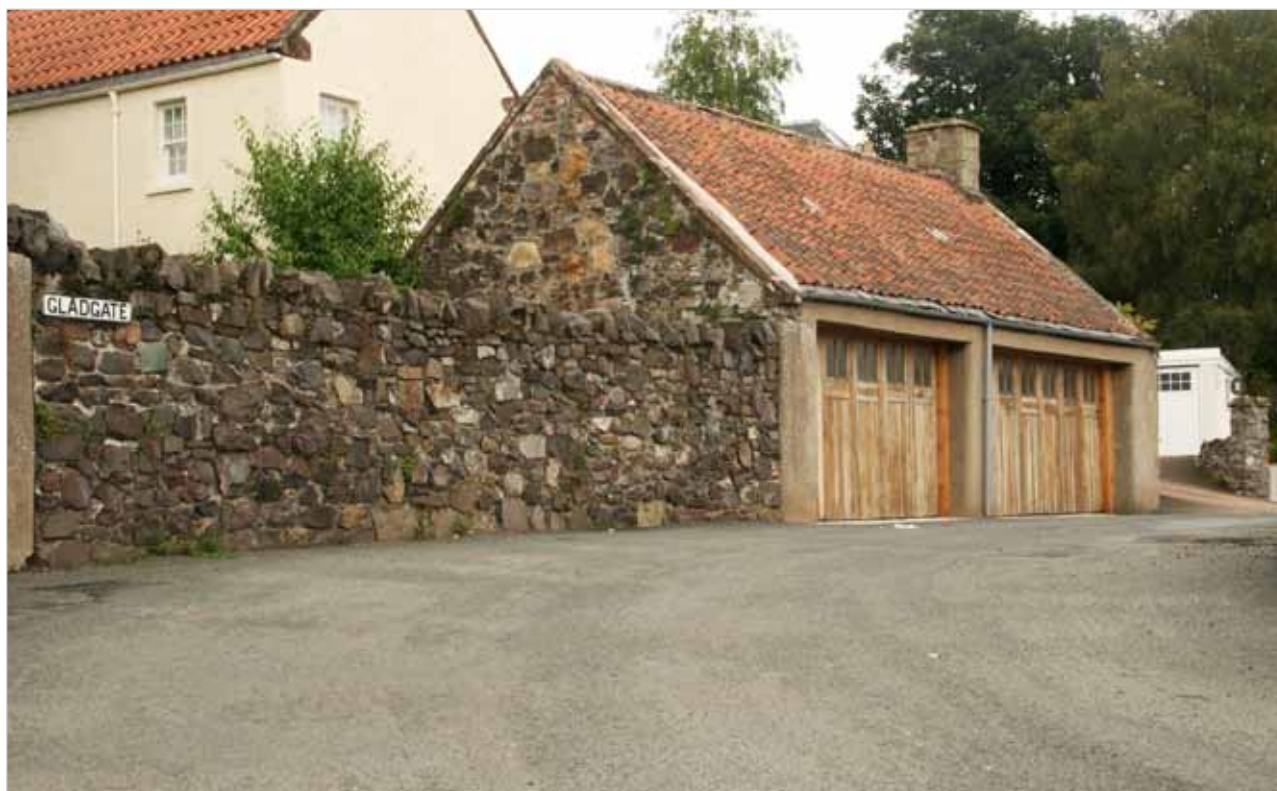
Address: ..... I Gladgate

**Additional Notes:** ..... 18th-century low two-storey house, listed as '*boulder rubble with margins, irregular fenestration, wooden porch; thatched*'. Either the grid reference held by Historic Environment Scotland and Canmore is incorrect, or the building has been heavily modified since the date of listing. The building has been converted to a garage and has a pantile roof. The listing description for this building should be updated accordingly.

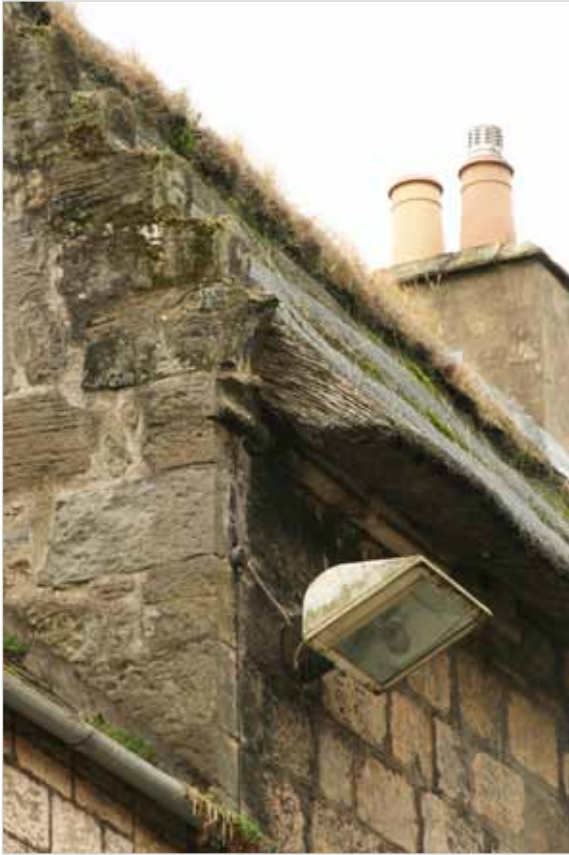
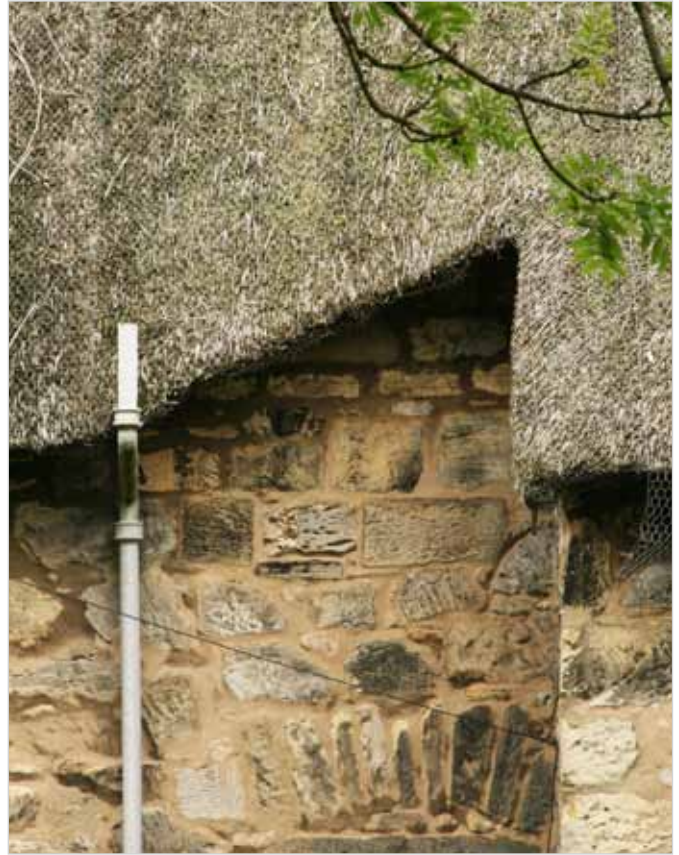
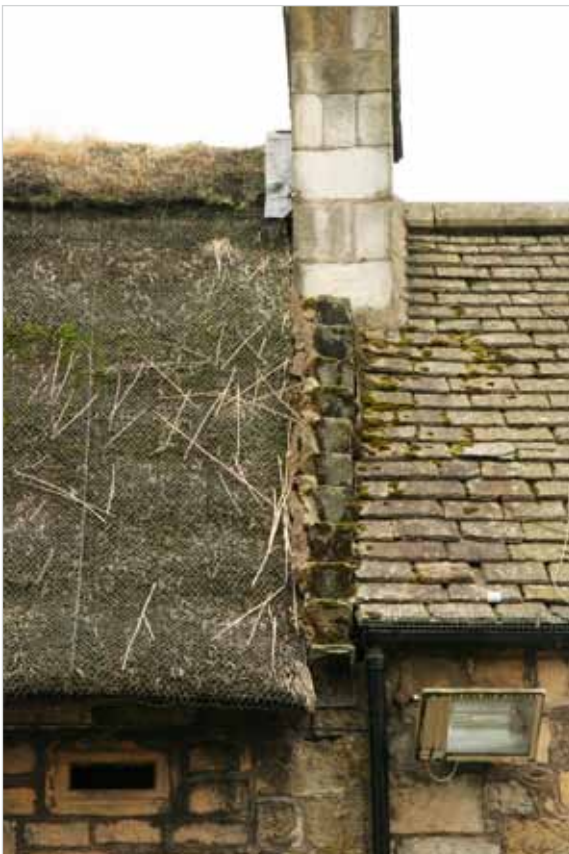
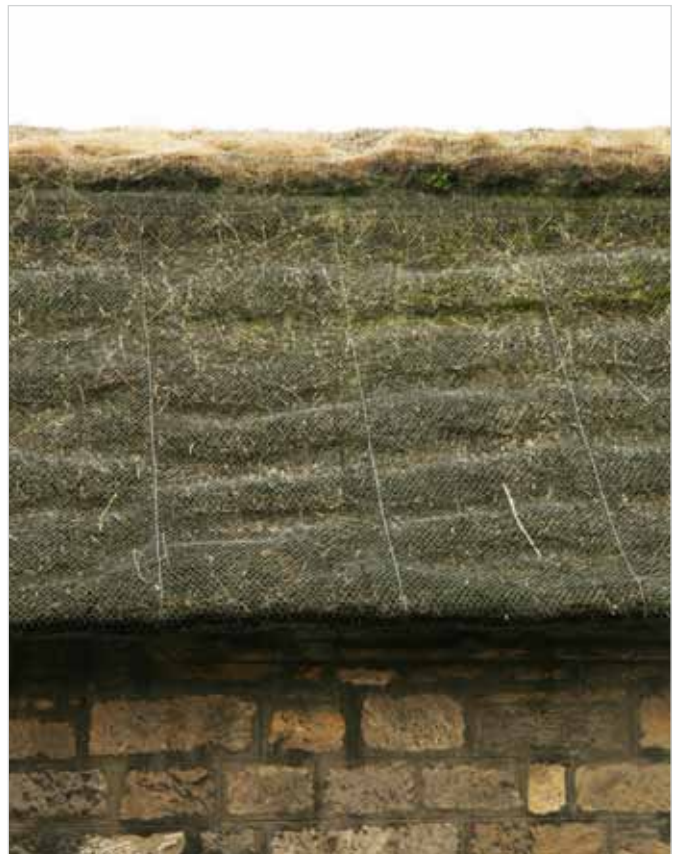
Moncrief House – Fife

Condition of Thatch: ..... Fair

**Additional Notes:** The building, which according to the listing description is 'dated NM AO 1610 at lintel', is comprised of two storeys with a dormerless attic. The roof is thatched in what appears to be reed, however due to the poor condition of the thatch it is difficult to determine for certain. The thatch has suffered deterioration, leaving the surface quite uneven. The whole thatch, including what appears to be either a turf or heather ridge, is netted. There are many loose pieces of thatch on the roof, some of which are only remaining in place due to the wire netting, and there is a large amount of visible mossy vegetation growth throughout. The raised

ridge is continued at a lower level directly below the central chimney stack, as well as below the chimney stack to the east. The cement fillet used between the thatch and the crow-stepped skews has deteriorated. On the rear (south) elevation there is an interesting angular shape to a section of the eaves.

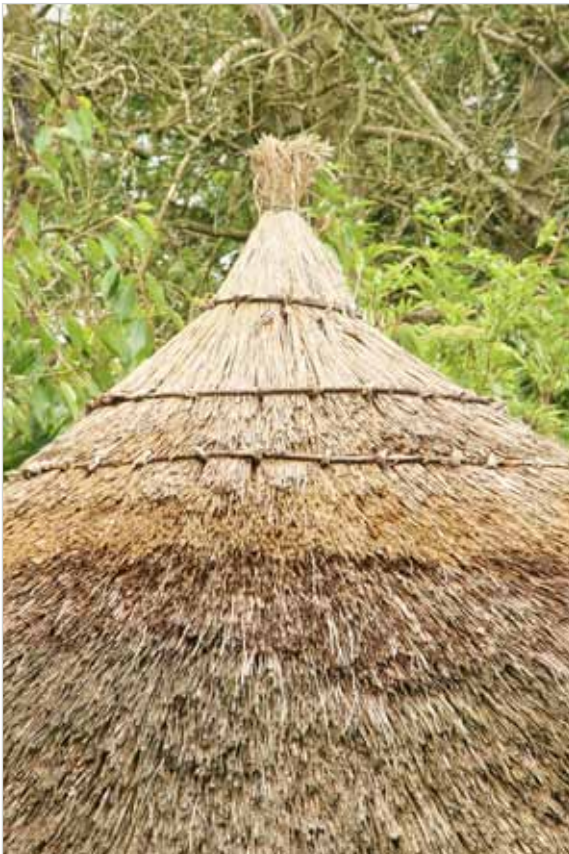
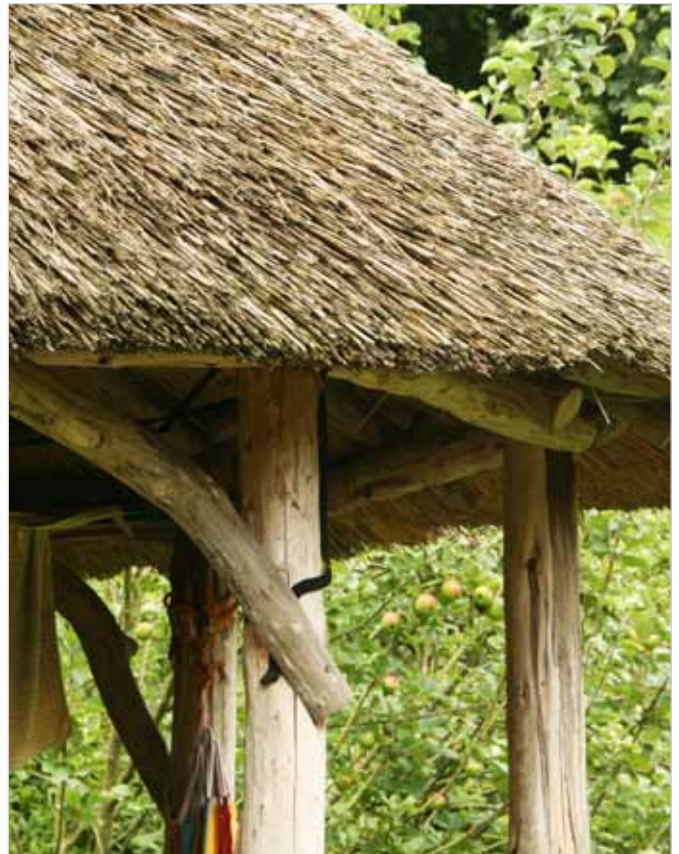
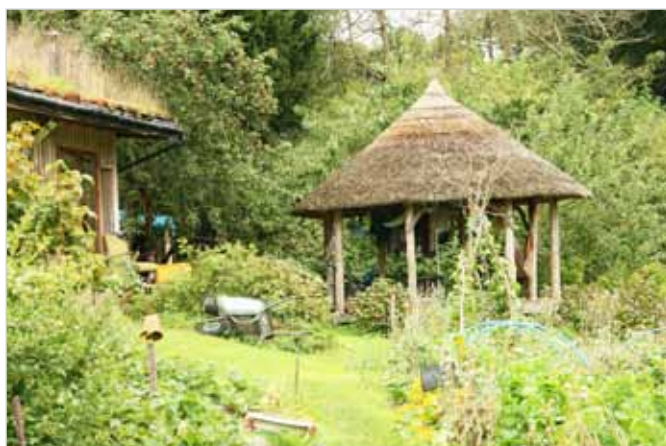
Monimail Gazebo – Fife

Condition of Thatch: ..... Good

**Additional Notes:** Timber gazebo of modern construction with conical thatched roof in the grounds of the Monimail Tower Project. The structure was built and thatched by Scottish-based thatcher Jeremy Cox, who is based in Castle Douglas and completed work in the nearby village of Collessie where there are a number of thatched cottages (see entries 076-080). The thatch is tied together at the apex and secured with three rows of hazel scobing. As well as the thatched gazebo, there is also an older thatched hut in the grounds of Monimail Tower. The hut is fairly inaccessible due to surrounding vegetation and appears not to be currently in use; however, the

thatched roof, which has some mossy vegetation growth on the surface, remains intact. It appears to be thatched in either reed or straw and is thought to have once been used as a chicken hut.

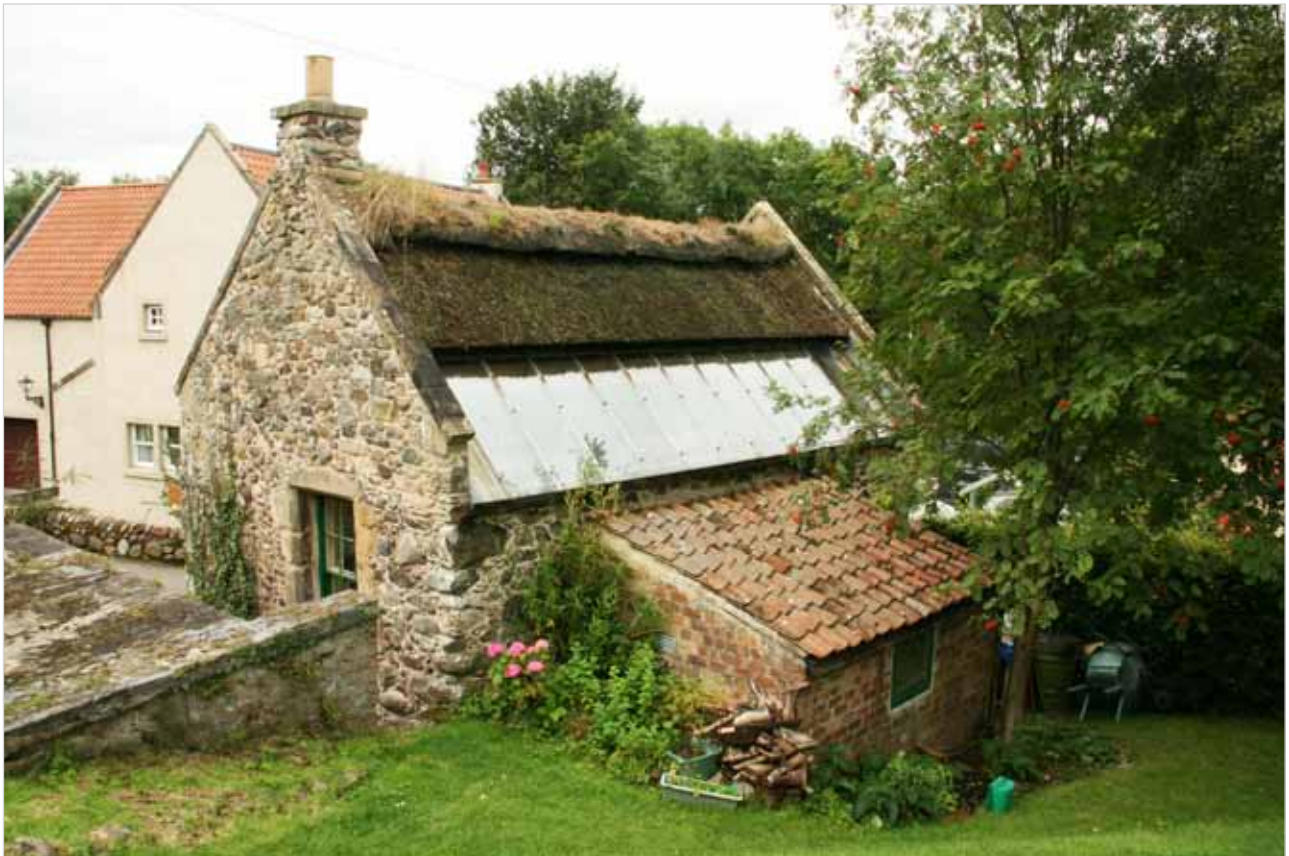
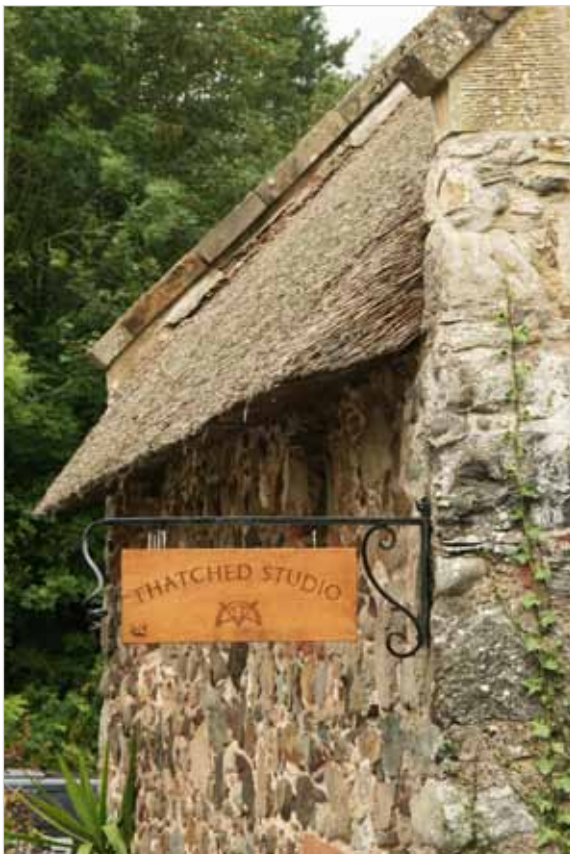
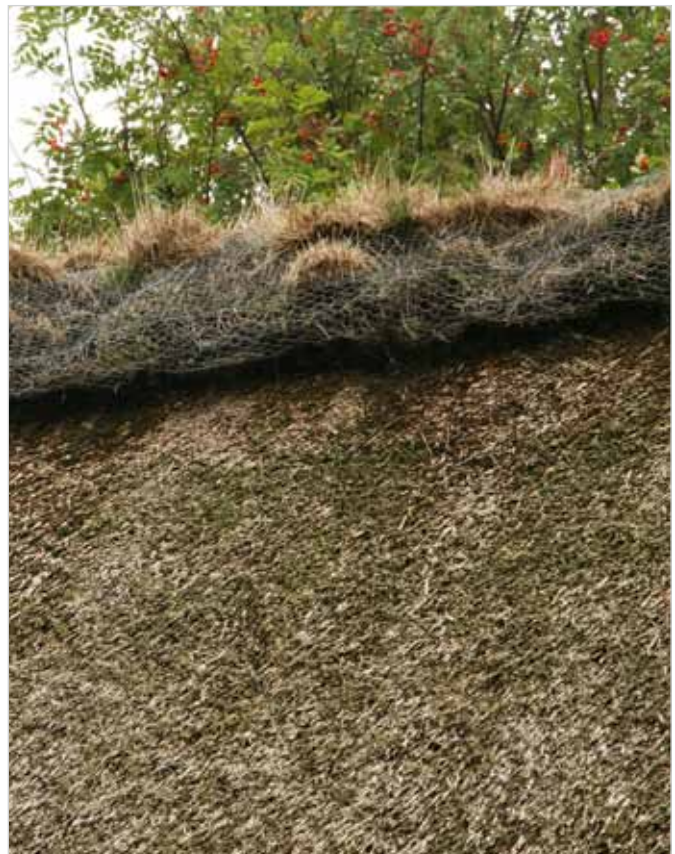
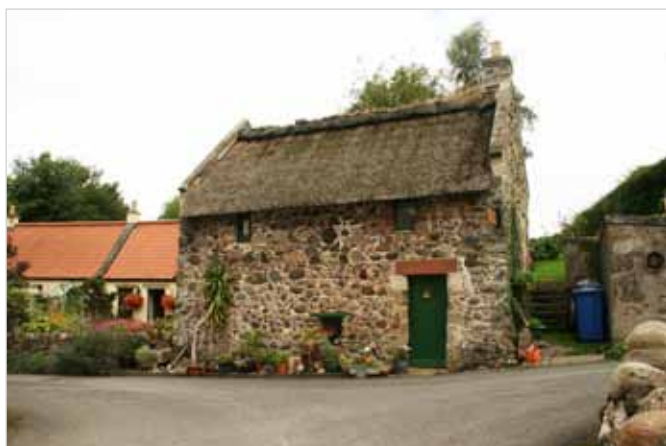
Braehead – Fife

Thatch Type: ..... Reed  
Ridge Type: ..... Thatched (Turf)  
Condition of Thatch: ..... Good

**Additional Notes:** Late 18th-century two-storey former village wash house, restored in 1995-98 by the current owner, who uses the building as an art studio. The restoration work was carried out by Fife-based Arc Architects. The building was thatched in reed and given a turf ridge, which is netted. In some places, the turf has grown quite extensively along the ridge. Due to the building's use and the need for additional natural lighting, the lower half of the roof on the north elevation has been glazed. The thatch, which other than along the ridge is not netted, is in a good condition; however, there is a small amount of mossy vegetation growth across the surface

of the thatch throughout. There is a single-storey brick extension to the north, which has a pantile roof.

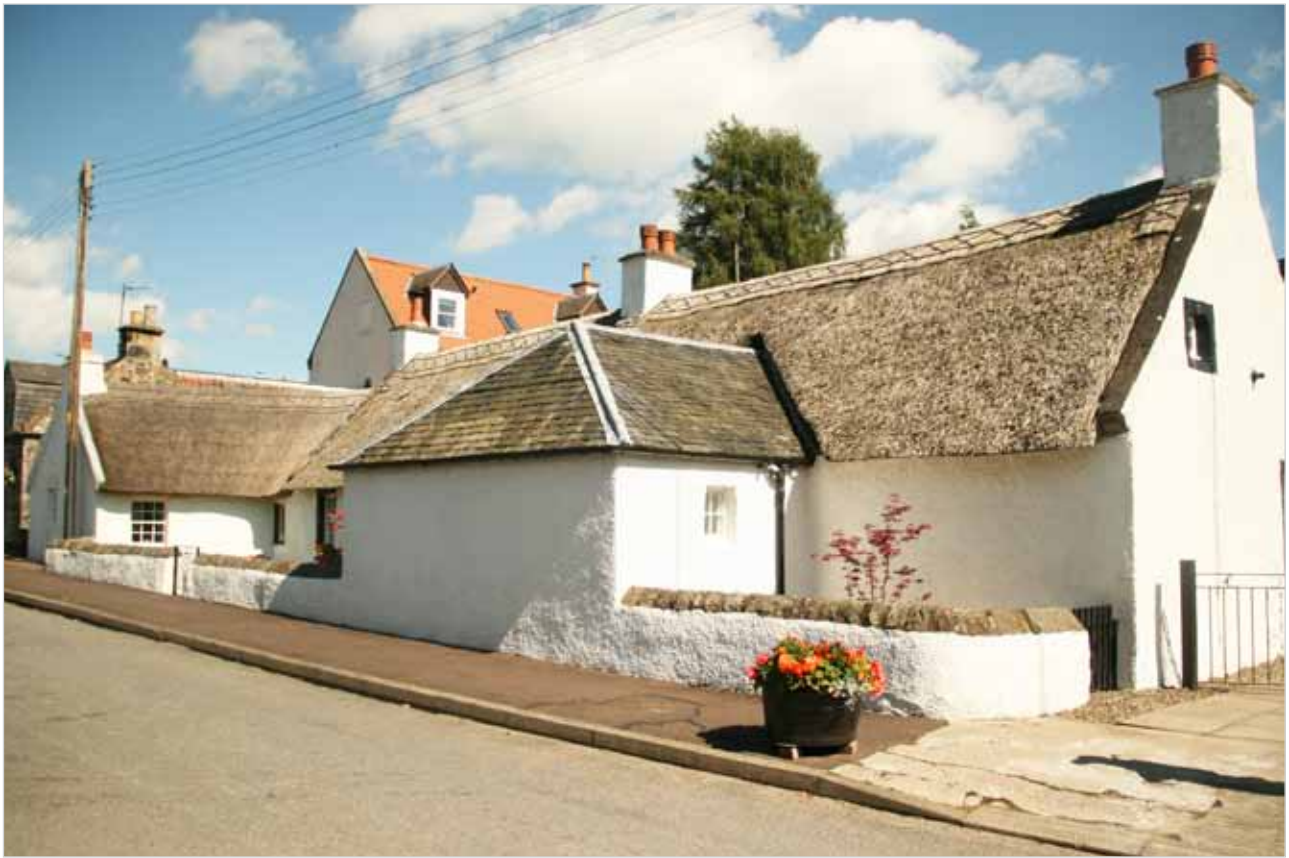
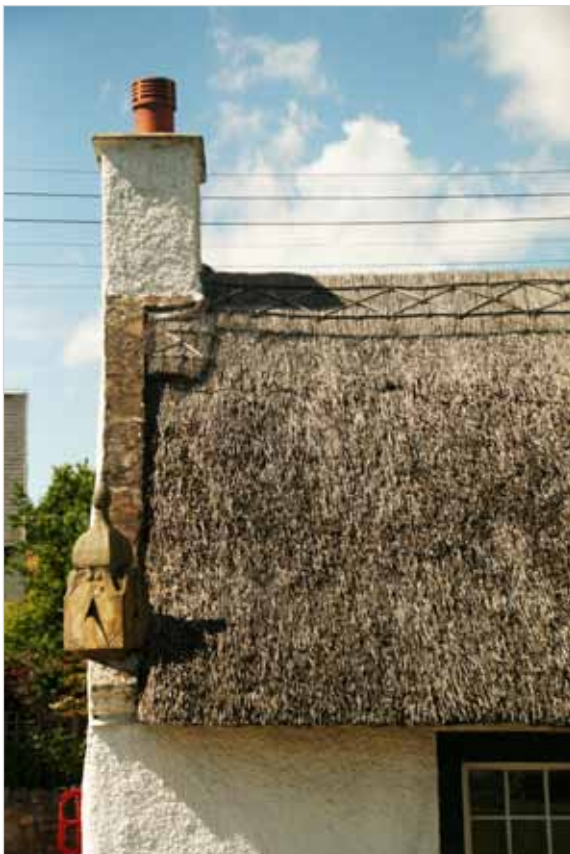
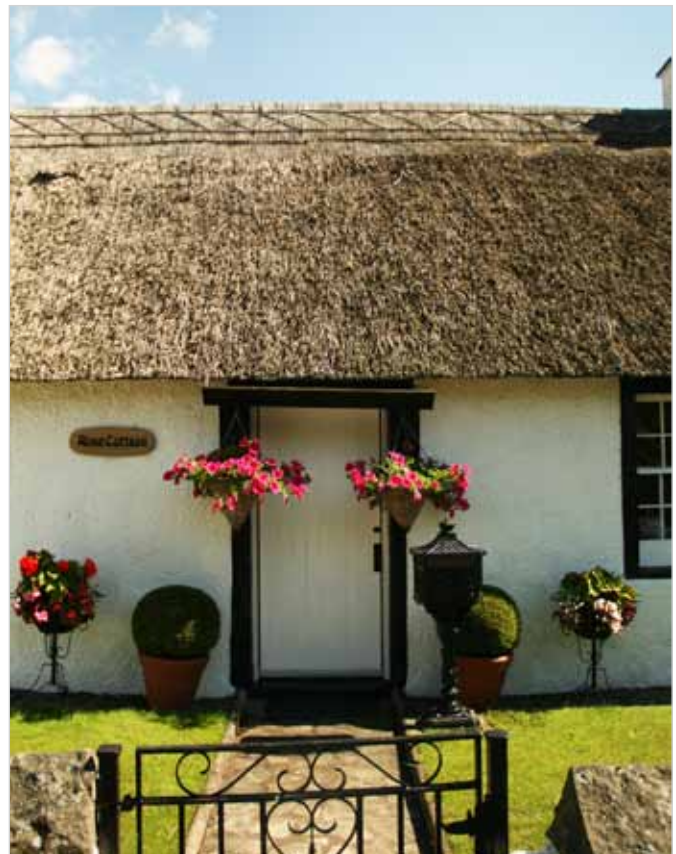
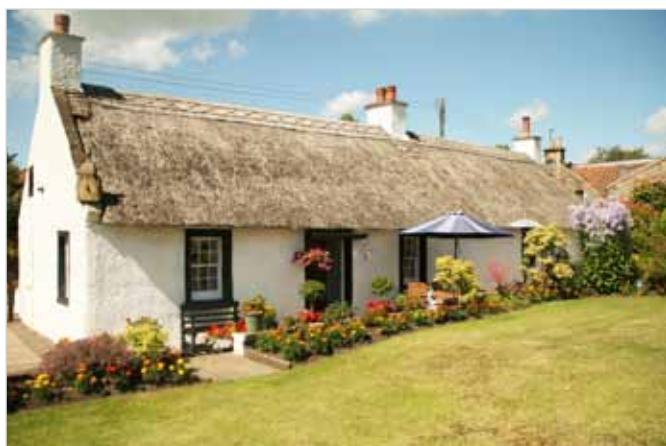
Rose Cottage – Fife

Condition of Thatch: ..... Good

a good condition and has been well maintained.
